Pedestrian Safety

Initiative Meeting #4
January 30, 2009

Piney Branch HIA: Timeline of Activities

Piney Branch HIA: Summary of Audit Findings

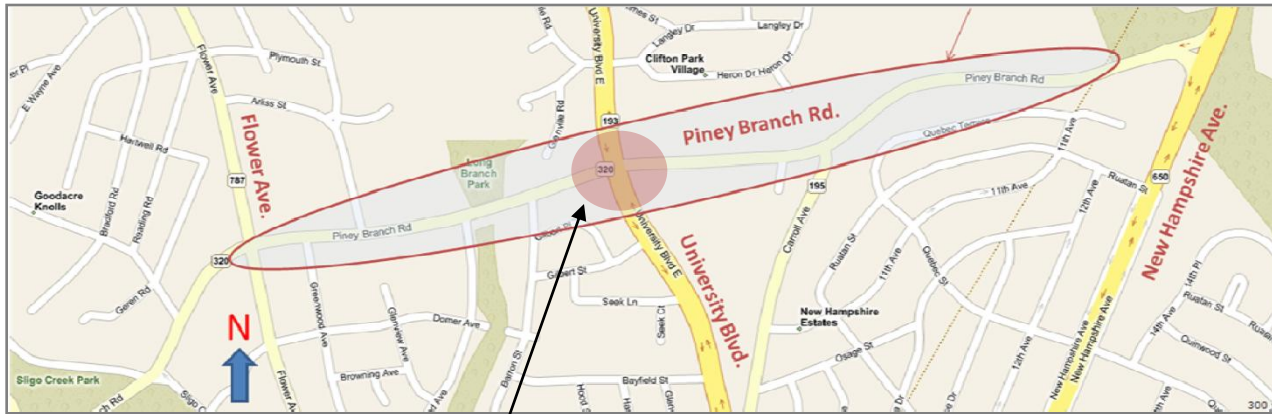
- First high incidence area: Piney Branch Road from Flower Avenue to the Prince Georges County/Montgomery County line

- Number of collisions
 - Intersection of Piney Branch Road and University Boulevard has the highest concentration of collisions
 - Total collisions in the High Incidence Area

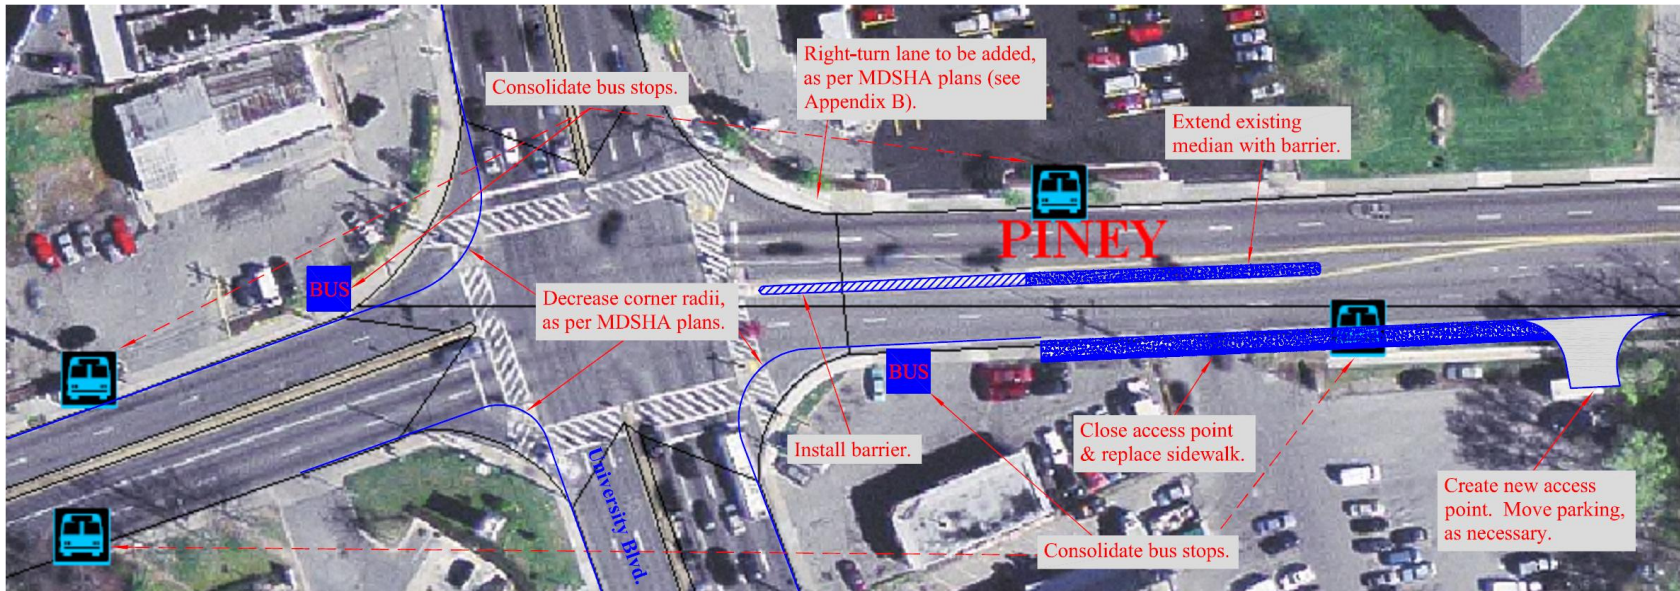
Piney Branch Road at University Boulevard

- Pedestrians often trace the shortest or most convenient paths.
- High numbers of pedestrians were observed to cross midblock at this location primarily to access the bus stops and also to the stores located on either side of Piney Branch Road.

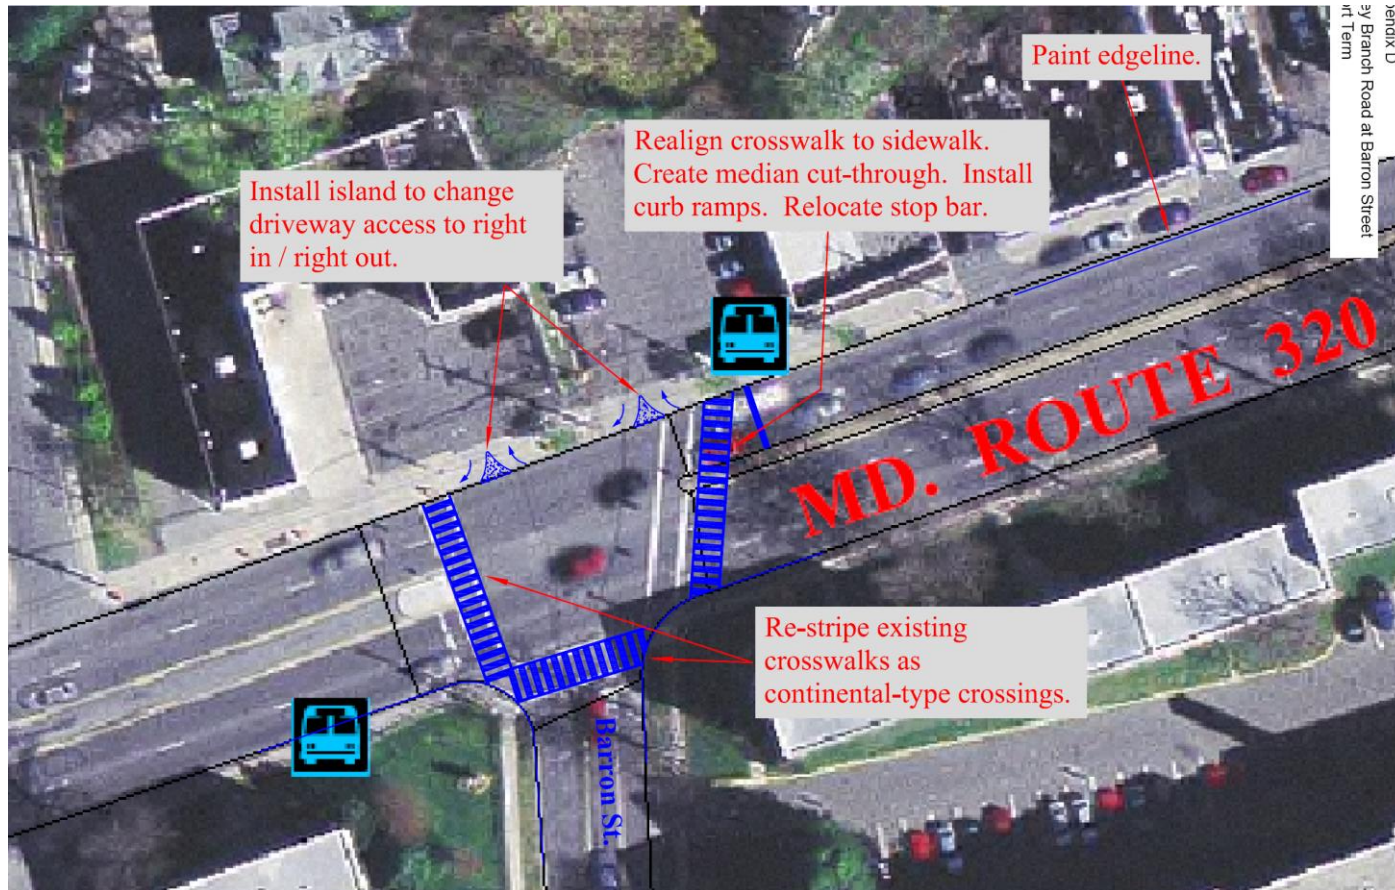
Piney Branch Road at Barron Street

Conflicts caused by multiple access points

Improper location of pedestrian push button

- The section between Barron Street and University Boulevard was observed to have poor night time visibility.
- Pedestrians crossing the street, especially midblock after disembarking buses were not seen by drivers until they were very close, causing the drivers to react on a very short notice.
- A resident noted this problem to the Road Safety Audit team during the field visits.

- *Short term:* Consider making the driveways right-in and right-out and relocating the crosswalk on the north side.
 - *Pro:* Left turn conflicts from driveways are eliminated
 - *Con:* Channels reduce effective sidewalk width which may cause pedestrians to walk through parking areas.
- *Long term:* Consider consolidating the three access points into one driveway and provide traffic signal control. Relocate crosswalk.
 - *Pro:* Multiple conflicts from driveways are eliminated
 - *Con:* Extensive coordination with business owners, loss of some parking.

- Ensure consistent level lighting between Barron Street and University Boulevard.
- Repair or replace the street lights between Barron Street and University Boulevard.
- Ensure that the bus shelters near Barron Street are lit.

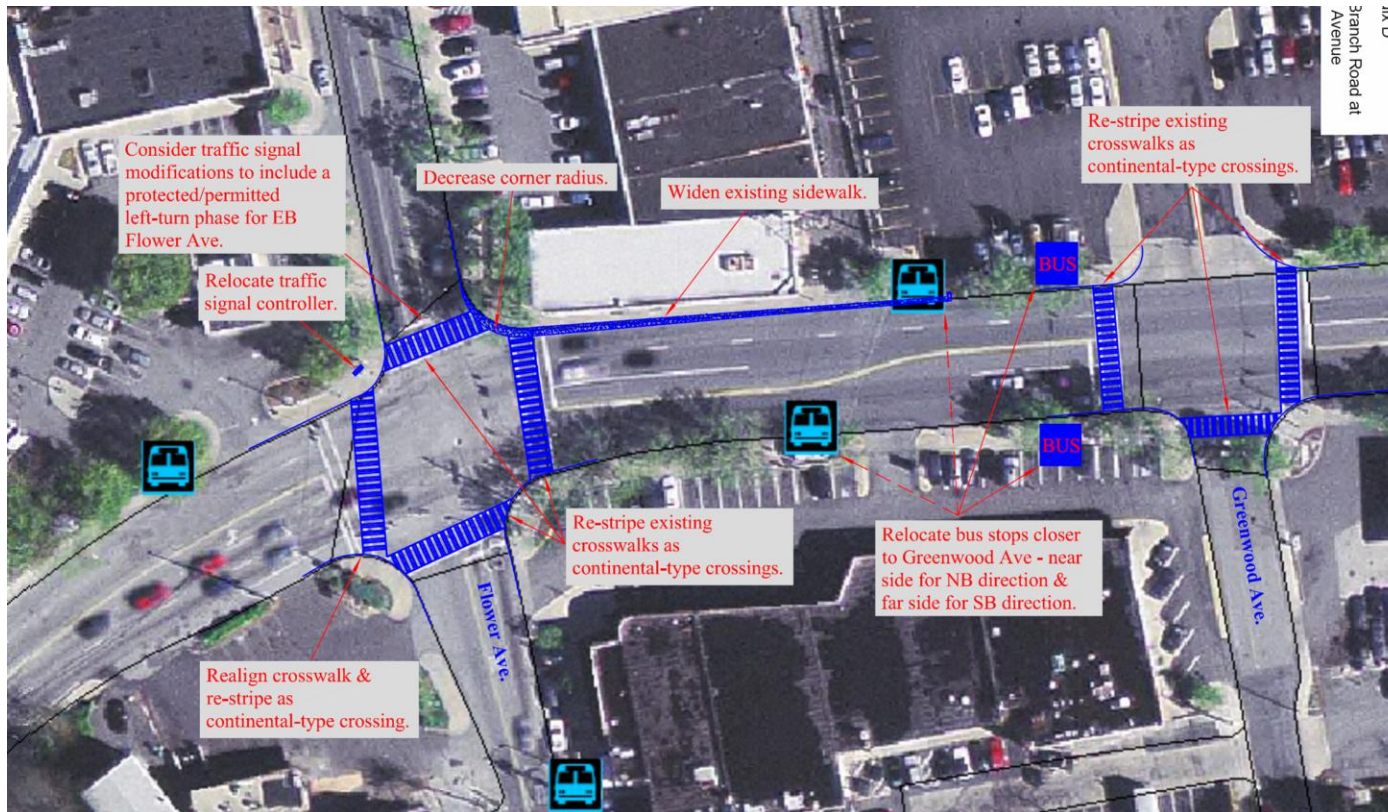
Piney Branch Road at Flower Avenue and Greenwood Avenue

- Southbound right turns from Piney Branch Road onto Flower Avenue are observed to not yield to pedestrians in the crosswalk or beginning to cross.
- A combination of vehicles traveling at high speeds and limited visibility at the corner may be contributing factors.

- High number of pedestrians were observed crossing midblock at the location of bus stops between Flower Avenue and Greenwood Avenue.

- Pedestrian signal heads are missing for approaches parallel to Piney Branch Road. This may result in pedestrians crossing with conflicting traffic.

- Ensure the pedestrian push buttons are in working condition at all four corners.
- Consider upgrading push buttons to the type that confirms the press.

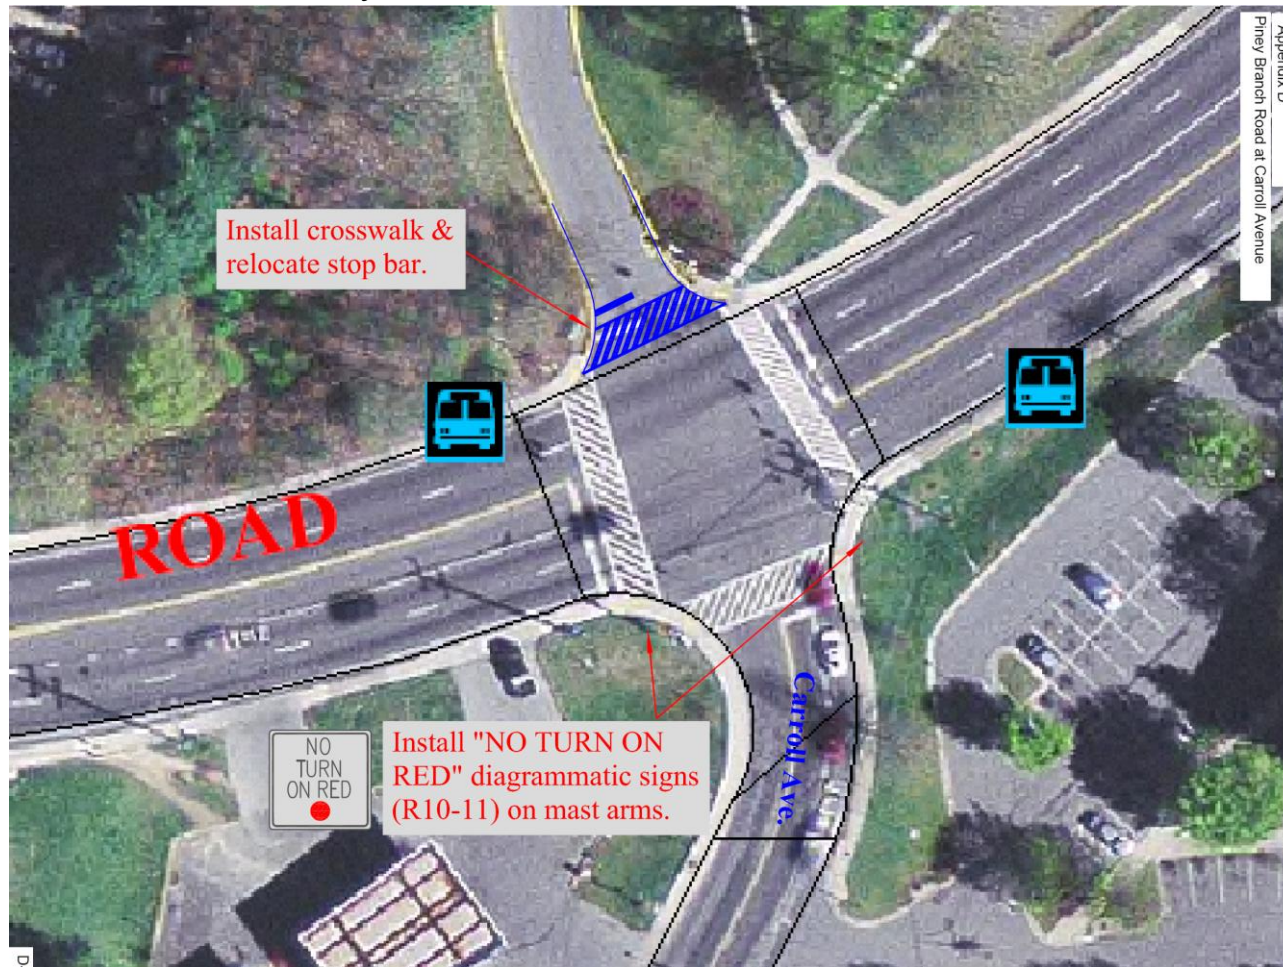
Piney Branch Road at Carroll Avenue

- Vehicles were observed to not yield to pedestrians in the crosswalk.
- Vehicles in the westbound left turn lane seem to be blocking the view between the pedestrians and right turning vehicles potentially creating a major conflict between them.
- This is especially critical as many of the pedestrians in this area were children, who may not perceive this threat and who present a smaller profile to motorists.

Missing crosswalk marking on west leg

- Over grown vegetation and foliage along side of the sidewalk appears to be protruding into the sidewalk, reducing the effective width of the sidewalk.
- This condition can create accessibility issues for pedestrian with mobility restrictions and reduce the capacity of the sidewalk system.

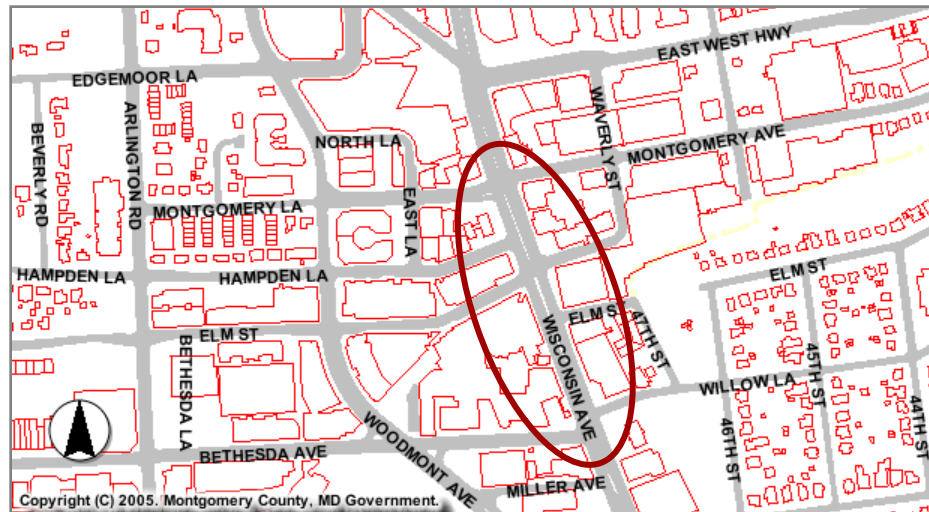
- **Second high incidence area: Wisconsin Avenue from Montgomery Avenue to Bethesda Avenue**
